BURGESS & NIPLE

Re: Traffic Signal Warrant Study
Columbia Street and Center Street

As part of our 2015-2018 General Planning Services contract we have completed a traffic signal warrant study for existing traffic signal at the intersection of Columbia Street & Center Street. Traffic counts at the intersection were conducted on March 12, 2015.

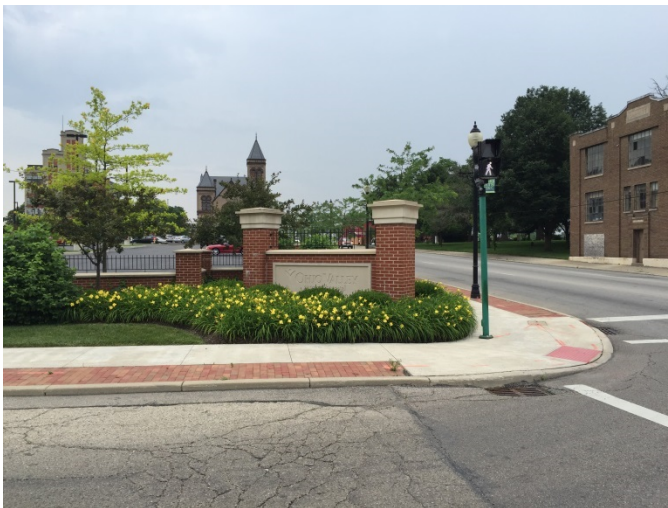
B&N conducted a site visit of the intersection on June 12, 2015. From this visit, no issues were discovered that would require the continued use of the traffic signal. The Ohio Valley Surgical Hospital sign located on the southwest corner of the intersection causes some sight distance issues for drivers stopped at the stop line. However, after stopping at the stop line and then rolling up a few feet, adequate sight distance exists to find a gap and safely enter the intersection. Photos from both the stop line and in front of the stop line are shown below. Several vehicles were observed during the site visit using this process to make a right turn on red. This condition exists at many unsignalized intersections and should not result in a crash problem at this location.

View from stop line

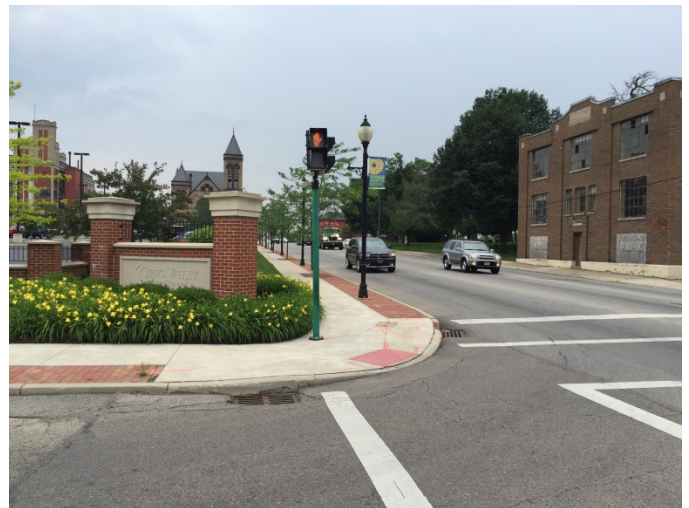
View from in front of stop line
